# SOURCE TRACKING PROTOCOL DEVELOPMENT PROJECT

FINAL GRANT REPORT

City of Santa Barbara

Creeks Division

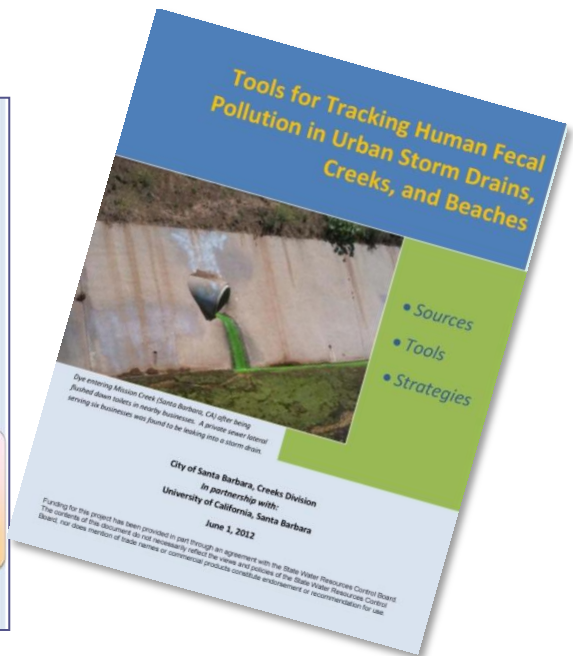
**FIGURE 4. TESTING AND INTEGRATING TOOLS AND PRODUCING AN ACCESSIBLE PROTOCOL GUIDE (APPENDIX A) ARE THE SHORT TERM GOALS OF THIS PROJECT.**

**The short term goal** of the research described here is to identify where, when, and how human waste is transported to storm drains, creeks, and beaches in Santa Barbara. By combining molecular microbiology with engineering tools, the research proposed to provide an urban detective toolkit that is needed to solve sustained contamination problems. The aim is to provide protocols for coastal managers throughout California to use for conducting source investigations of storm drains that produce exceedences of AB411 indicator bacteria standards (Figure 4). Tools include:

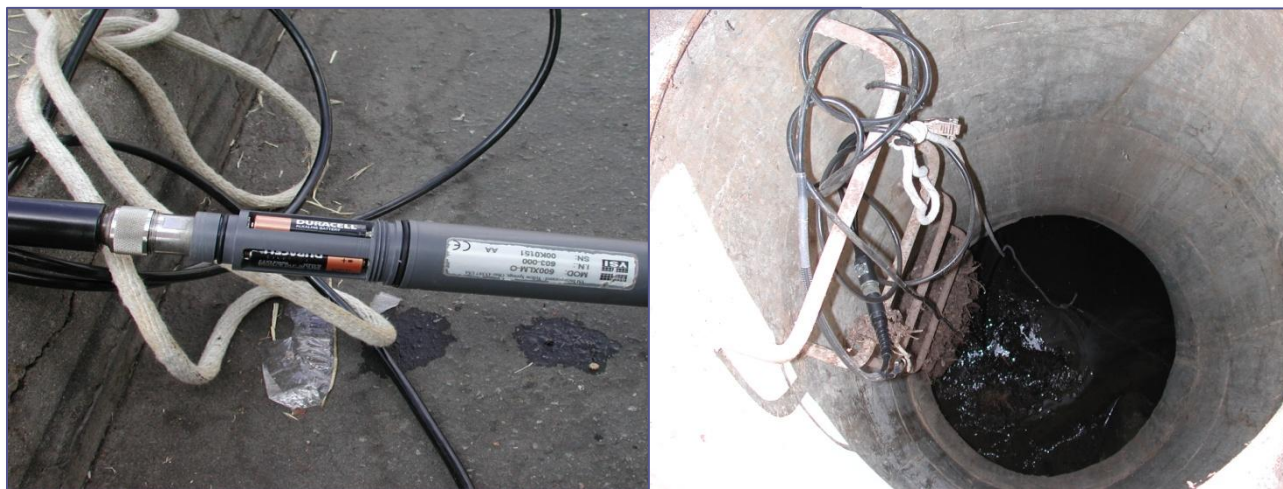
**FIGURE 8. RHODAMINE WASTEWATER TRACER (RWT) PROBE INSTALLED IN URBAN MANHOLE.**

drains. Approaches for studying exfiltration in the field were researched, and a novel approach was developed that involved dispensing rhodamine wastewater tracer (RWT) dye into sanitary sewers and detecting a fluorescence signal continuously, in real time, in storm drain manholes using a field-deployable, battery-driven submersible optical probe with data logger (UCSB Final Report Chapter 4, Figure 8 below).

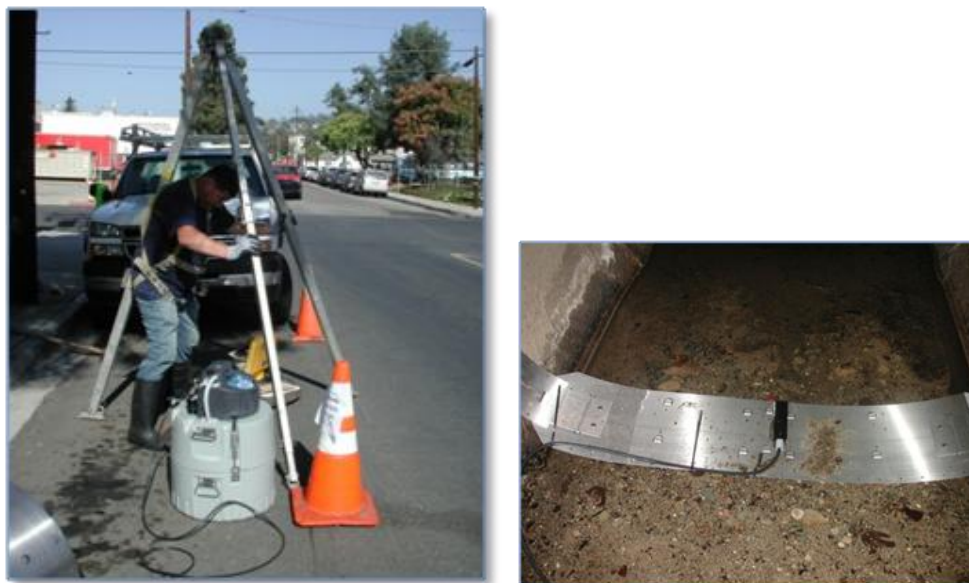
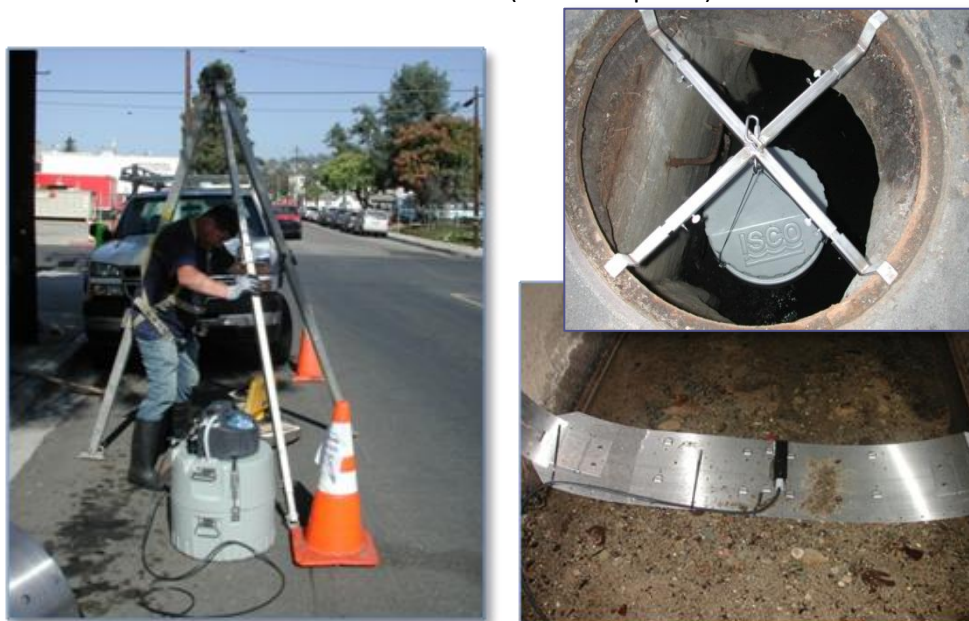
**FIGURE 9. FLOW GAUGE AND AUTOSAMPLER DEPLOYED IN URBAN STORM DRAIN.**

Figure 9 below). Samples from these campaigns were analyzed for FIB and markers of human waste, plus nutrients and chemical markers of human waste (CUSB Chapter 7).

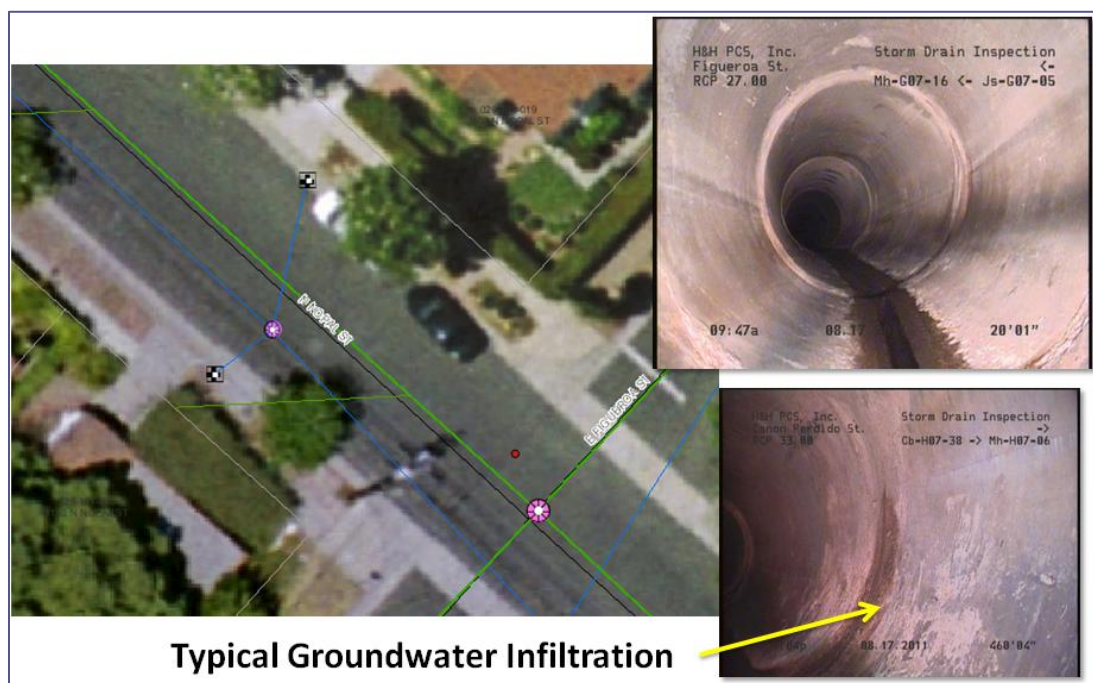
**FIGURE 12. CLEAN GROUNDWATER INFILTRATION IN NOPAL STREET STORM DRAIN. IN MAP ON LEFT, BLUE LINES REPRESENT STORM DRAIN PIPES AND GREEN LINES REPRESENT SANITARY SEWERS. PANEL ON UPPER RIGHT SHOWS FLOW OF VISUALLY CLEAN WATER IN STORM DRAIN. LOWER PANEL SHOWS TYPICAL VISUAL OF OSTENIBLY CLEAN GROUNDWATER SEEPING INTO STORM DRAIN AT PIPE JOINTS.**

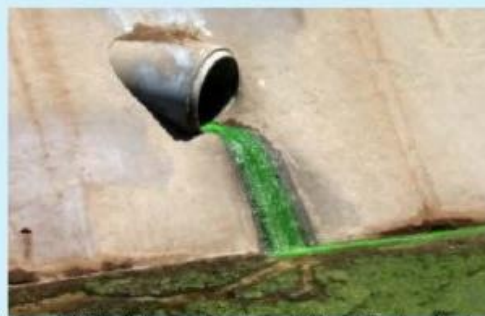
*PHOTO: Dye testing revealed that private sewer laterals were leaking into the storm drain system, which flows from the Carrillo Drain into Mission Creek.*

The first source was comprised of untreated sewage from a commercial building, where a broken private lateral crossed through the top of the brick and mortar roof of the storm drain. The second, a much slower leak, came from a failing private lateral serving another commercial building.

Within 24 hours of confirming the sources of the leaks, contractors hired by the property owners had repaired the broken sewer laterals.

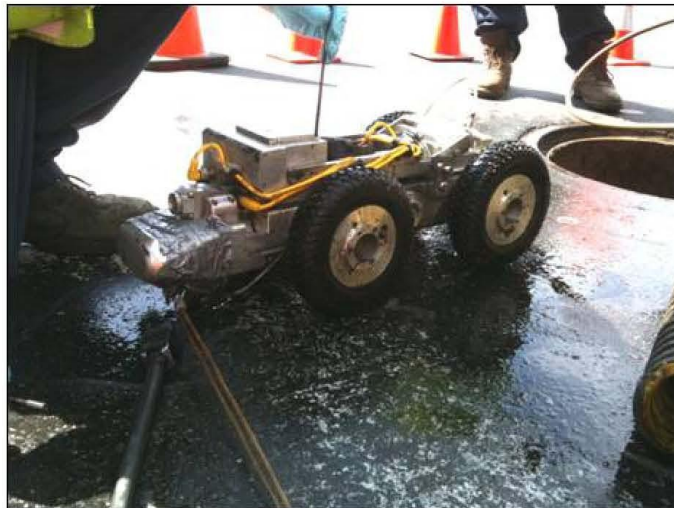
Staff suspected a broken sewer lateral could be the source of the problem, so the Creeks Division hired a contractor to survey the interior of the storm drain using a state-of-the-art robotic camera (see photo above). Our suspicions were confirmed when two locations were found where water was dripping into the storm drain (see screen shot below).

**FIGURE 15. SEWAGE LEAK INTO CARRILLO STREET STORM DRAIN, PART 2.**

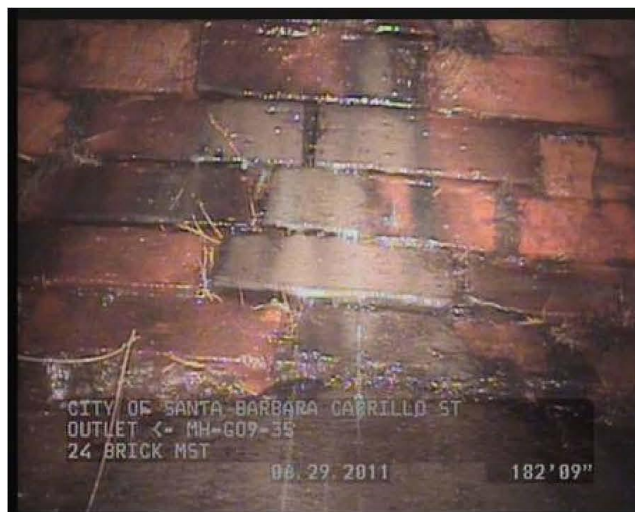
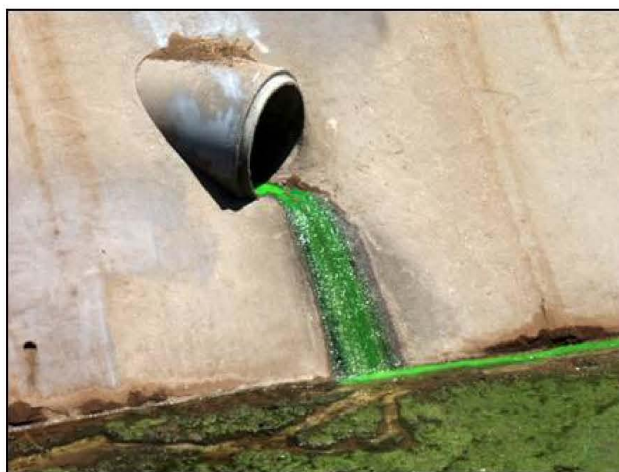
The next day, Creeks Division and Wastewater Division staff flushed fluorescent green dye in the toilets of nearby businesses (USGS confirms that this dye can enter creeks without causing toxicity problems). After a few flushes, the bright green stream was observed flowing out of the storm drain into Mission Creek (see photo below).

**FIGURE 16. SEWAGE LEAK INTO CARRILLO STREET STORM DRAIN, PART 3.**

A similar procedure was used to identify the second leak, and private property owners repaired the leaking sewer laterals within 24 hours of confirming the sources (see photo of one repair below). Following the repairs, the Creeks Division has observed no water at all coming from the Carrillo Drain into Mission Creek.

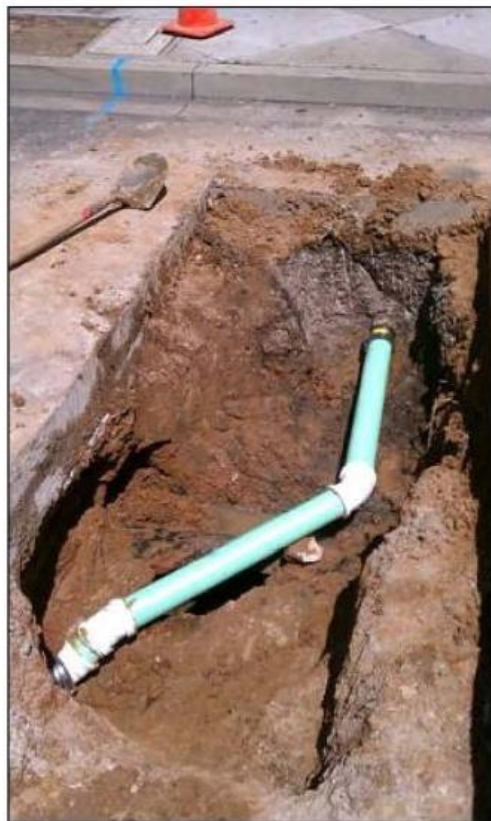
**FIGURE 17. REPAIR OF SEWAGE LEAK INTO CARRILLO STREET STORM DRAIN.**
